# Elan Factory Customer Projects

August 2007

## Vehicle details

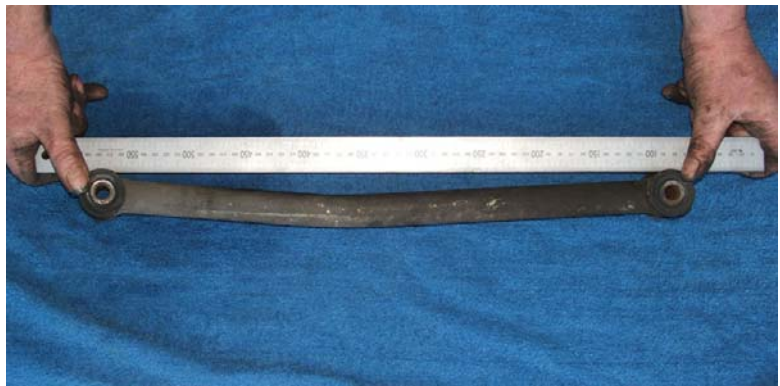
This Esprit is a regular visitor to The Elan Factory. There have been some interesting problems to resolve over the years and they include a glowing/over heated exhaust system. This was diagnosed as a faulty primary catalytic converter where the internal core had come loose and rotated its self through 90 degrees blocking off the exhaust gases. The Valeo 90 Amp alternator developed a fault when one of the diodes failed in the three phase rectifier. This recent visit revealed there was a bent rear suspension arm – probably the result of the vehicle being incorrectly jacked when new wheels were fitted.

Bent rear suspension lower control arm

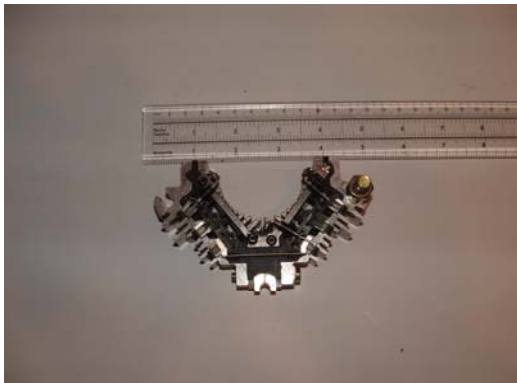
Three phase rectifier, rear view

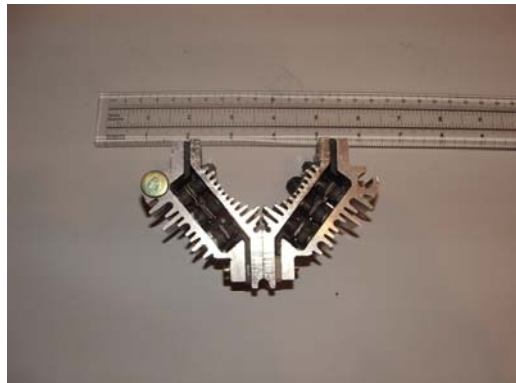
Three phase rectifier, front view
