Elan Factory Customer Projects

July 2007

Vehicle details

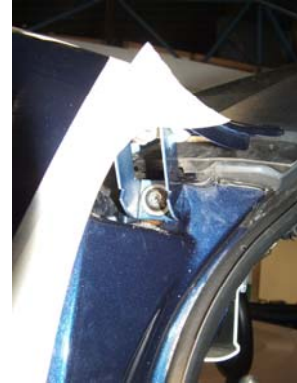
Seized stainless steel fastener at the bottom of passenger side windscreen pillar

Replacing the blower motor and/or speed resistor pack involves removing the complete front body section car to gain access to these components. This is normally straightforward providing the stainless steel fasteners are easy to remove. This particular Elise had been exposed to a UK winter where the body fasteners had started to corrode. This resulted in having to remove the passenger door to gain full access to the "frozen screw" located at the bottom of the windscreen pillar. This problem could easily be avoided by if the good people at Lotus Cars would take a few extra minutes to coat all relevant fasteners with an anti-seize product. This would save so much pain and expense to servicing personal and Elise owner's.

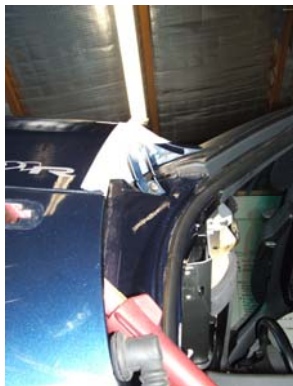
Fastener access is severely restricted

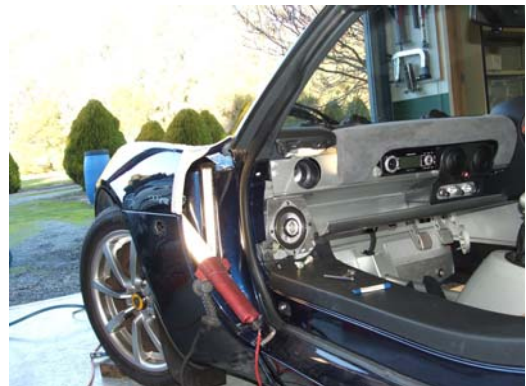
Passenger door removed to improve access

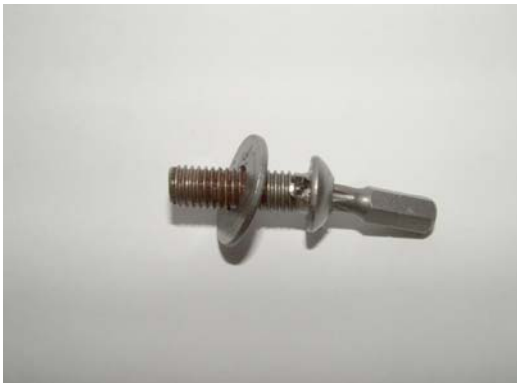
Offending "frozen screw" and driver bit

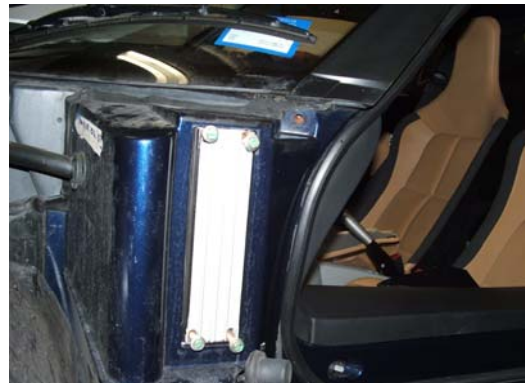
Passenger side door hinge mounting

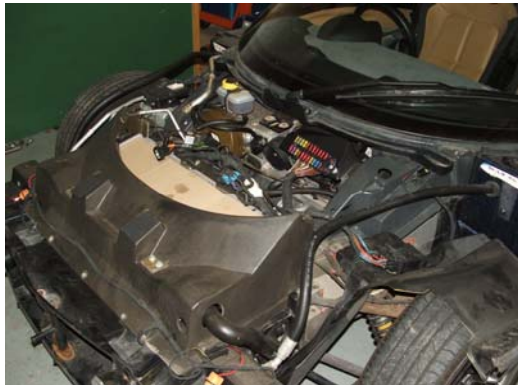
Protective cover installed on top of radiator

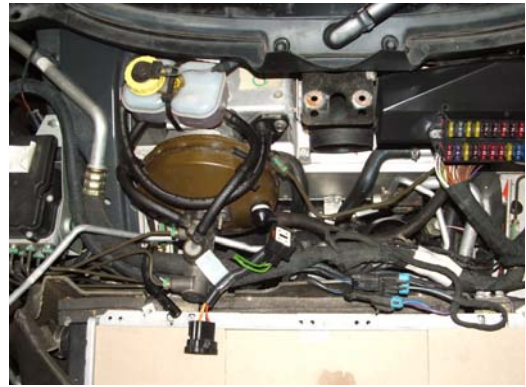
Blower motor unit is located under the brake servo

The "troublesome blower motor" is located underneath the brake servo unit and is firmly tucked under the chassis rail. But first, the heater-A/C unit had to be rotated to allow it to be withdrawn from the rectangular chassis compartment.

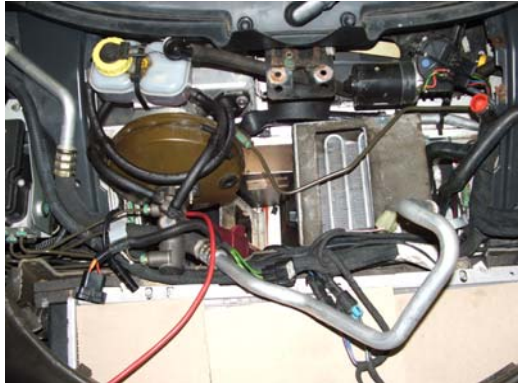
Heater & A/C unit rotated

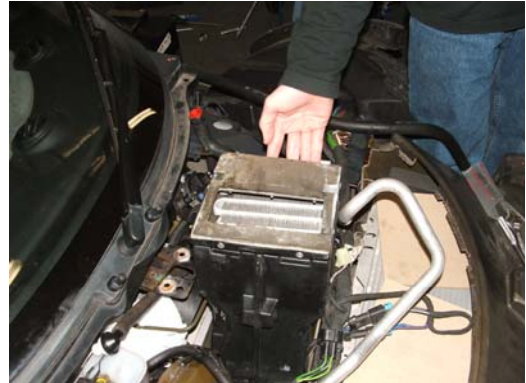
Heater & A/C unit slides upwards to remove

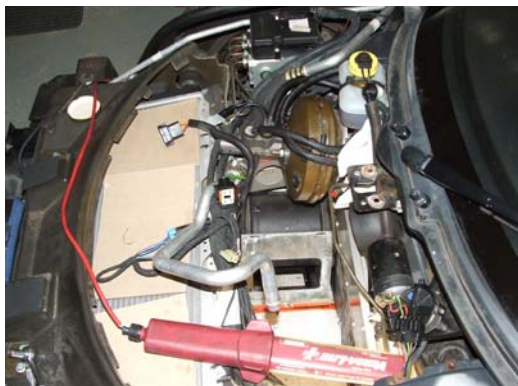
Blower unit is located under the chassis rail

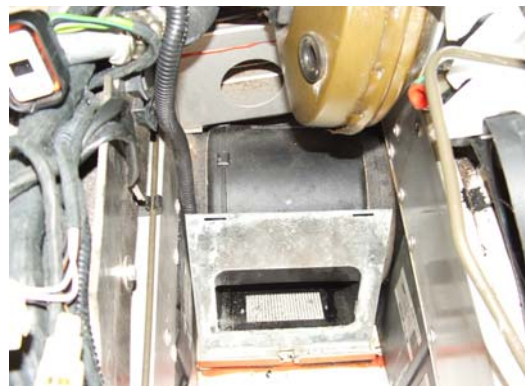
Blower unit has to be moved over to the centre of the vehicle before it can be lifted out

Once this was removed then it was possible to slide the blower motor towards the passenger side and then withdraw it upwards. When the blower motors are side by side, there are some subtle differences – please see photograph above. This may explain the different Lotus part numbers.

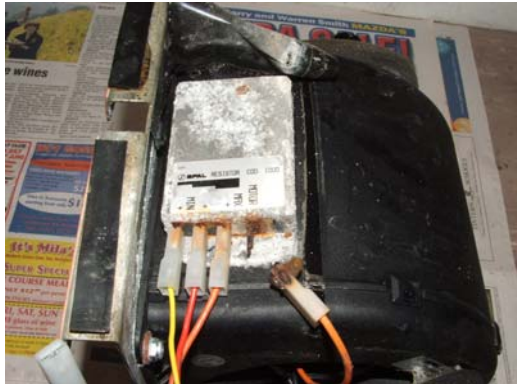
Corroded speed control unit mounted outside

The resistor pack is very basic as it's a series of nickel-chrome wire wound resistors mounted inside an aluminium case. Unfortunately the resistor pack is mounted externally (underneath the blower plastic case) and not subjected to any air flow to help cool it. The "cheese-grater fins" on the resistor pack case are intended to provide a heat sink cooling surface (but is on the wrong surface as the resistor pack sits proud on the other side of the casing) This arrangement can be improved upon by mounting the resistor pack inside the fan assembly so it sits in the air stream and not subject to water.

The compartment had a significant amount of water in it and had to be drained before all the components could be installed back in their original locations. This was determined by the tide mark on the black plastic tape covering the resistor pack. Once the water got into the resistor pack and the connectors, this has initiated the corrosion process. Once the corrosion had taken a hold of the connectors, this in turn has caused a high resistance joint. Once you have a high resistance joint, then a volt drop develops across the connector. When a volt drop is established across an electrical connector, then heat is developed and the final result is what you see in the photograph above.

- 1) The resistor pack is prone to being bathed in water
- 2) The resistor pack sits in a "dead zone" where air cannot circulate around it
- 3) The resistor pack cannot be accessed easily from a service point of view

Unfortunately there is not an elegant solution to this particular problem as there are constraints imposed by the existing components and their layout. However, it would be straightforward to design an external solid state speed controller mounted on an aluminium heat-sink. This could simply be bolted to the body/chassis to be easily accessible and not have to dismantle half the vehicle to access the blower unit/resistor pack.

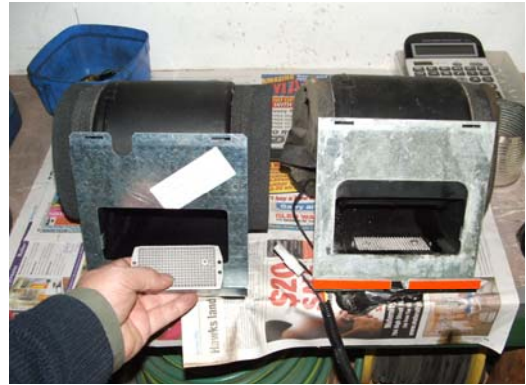
There was no point in returning these parts to the UK so a decision was made to adapt what was supplied and improve on the original installation. A quick check revealed the blower unit had no cut-out in the plastic casing for the resistor pack to be installed in its original position. In addition to this the resistor pack had the incorrect plug installed on the end of the cable.

Replacement blower unit is not the same as the original

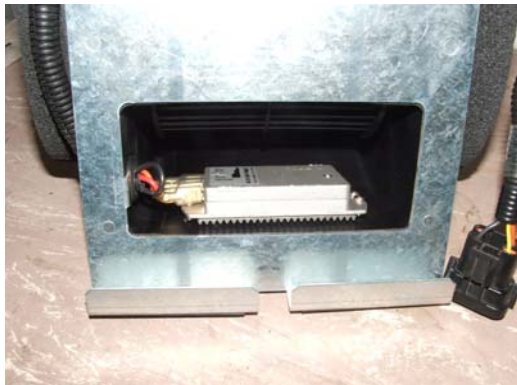
Speed control unit mounted inside blower

After examining the short falls in the original blower motor and resistor pack installation, a decision was made to mount the resistor pack internally within the blower unit.

- a) The resistor pack is away from any water source.
- b) The resistor pack is directly in the air stream and is cooled whenever the fan is operated.
