May 2007

Lotus 7 - Clutch Nightmare

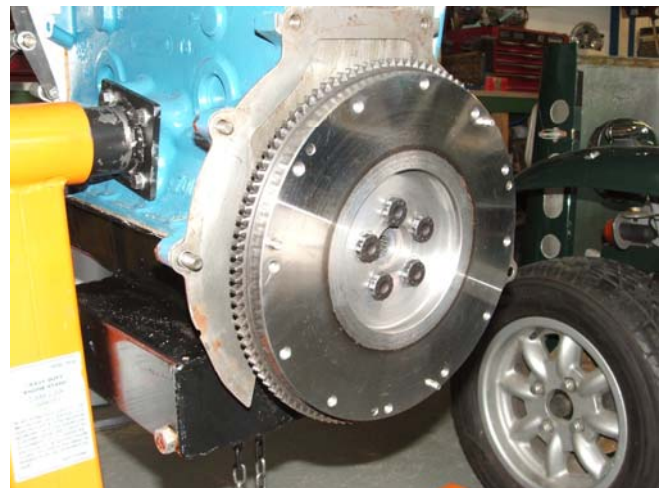
After removing the engine gearbox from the vehicle, this allowed a more detailed examination of all the components. The clue to this particular problem was a narrow 6mm wide heat band that can be clearly seen on the photograph of flywheel friction surface.

During normal operation, the clutch friction pad would contact the full width of the material without showing signs of over heating. To better understand this fault, see the clutch diagram on page 7.

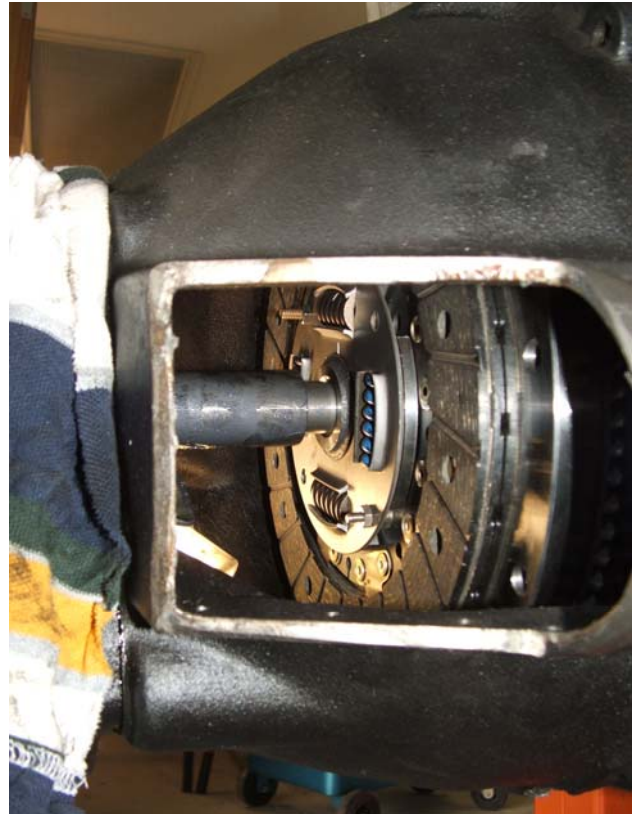
Once the closing plate had been removed, this gave an unprecedented view of the clutch friction plate, flywheel and gearbox input shaft. Despite flipping the splined centre over so the off-set is towards the crankshaft there is minimal spline exposed. However this modification finally produced 3mm to 4mm end-float which will only improve as the clutch friction material wears.

Note the fixing screws and nuts holding the centre spring plate together.

Before final assembly and riveting process took place, the plate was temporarily assembled with some small screws and trial fitted to the gearbox input shaft to check the end-float/spline clearance.

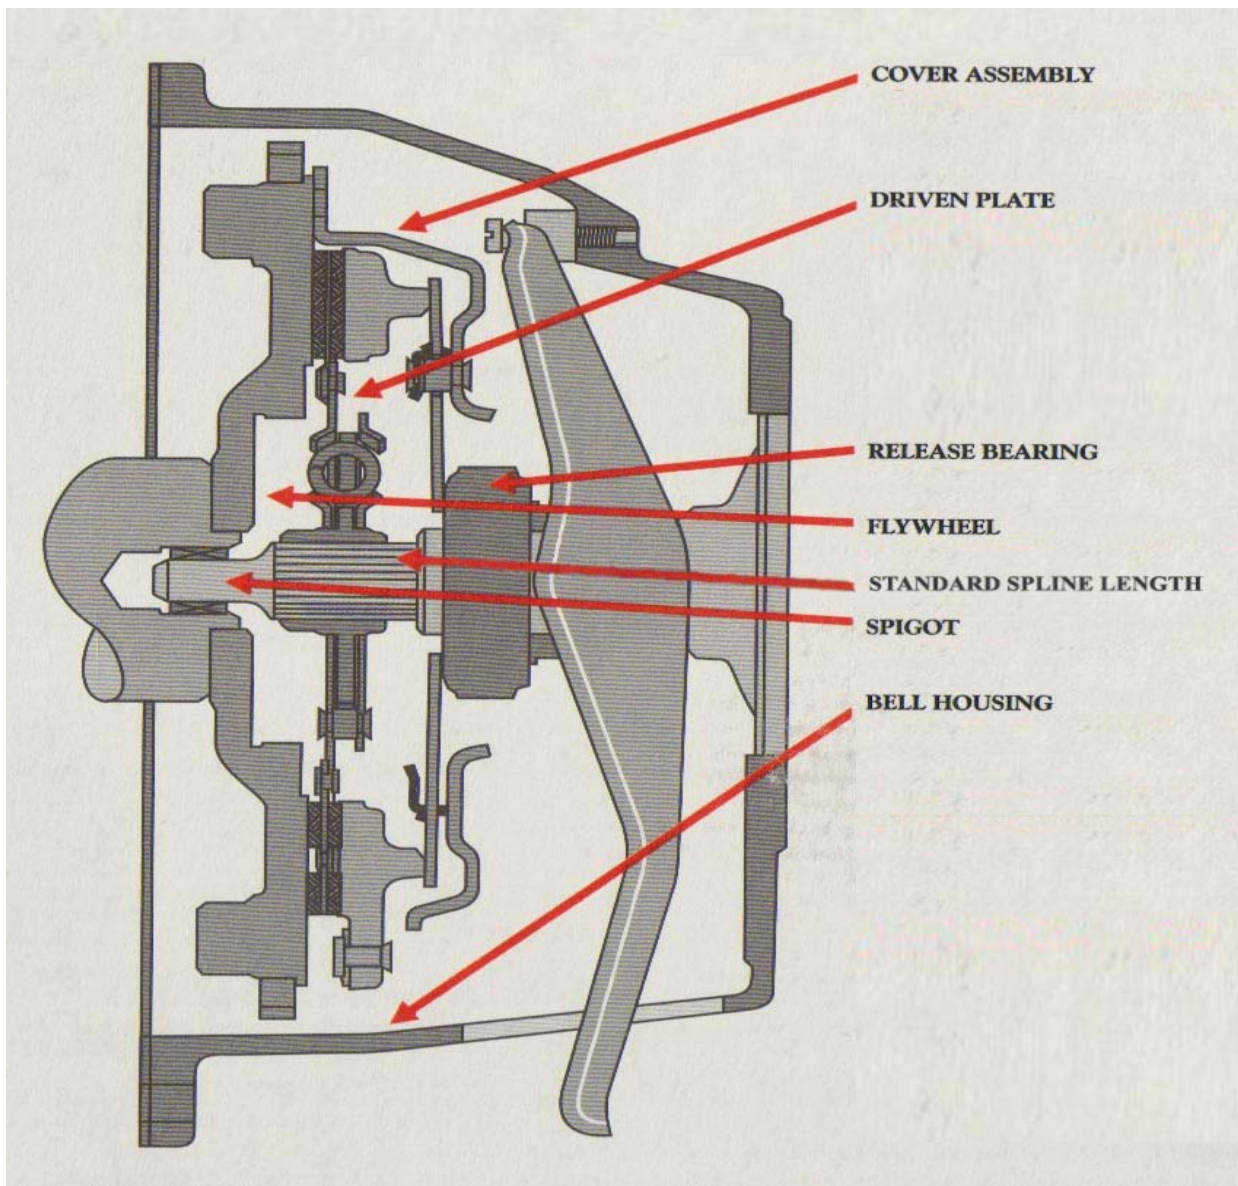
This diagram depicts a standard clutch assembly, flywheel and bell housing. There are several points of interest which are:

- a) The input shaft spline and how it extends from the spigot to the release bearing carrier housing
- b) The clutch driven plate position and appearance (not distorted)
- c) The clutch friction material and how it is clamped between the flywheel and pressure plate
- d) The spigot and how it locates inside the crankshaft

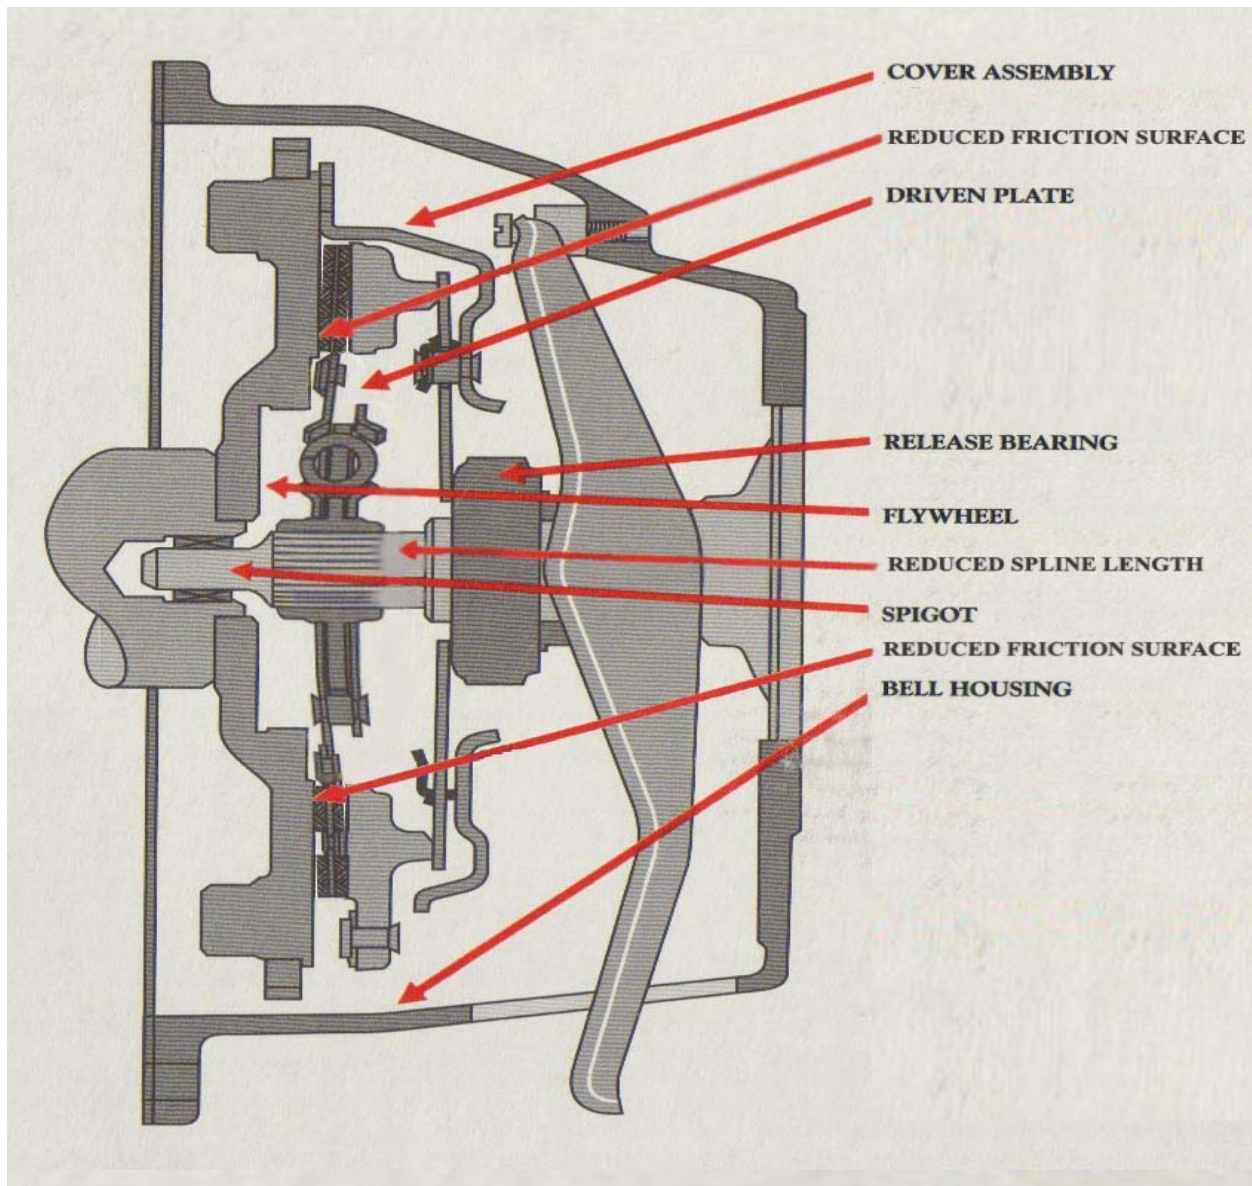
Note the very small air-gap created by the distorted friction material on the diagram

The driven plate has been distorted by the centre bottoming out on the splines and forcing it to take on a dish shaped appearance.

This diagram illustrates the clutch problem where the friction plate (driven plate) has no clearance on the gearbox input shaft splines. The friction plate is significantly distorted by being forced forward towards the end of the crank shaft. The driven plate assumes a dish-like appearance because of the reduced spline length on the input shaft. To prevent this from happening, there would normally be a reasonable amount of spline extending well into the release bearing carrier housing. If you look carefully you will note the friction material only contacts the flywheel on the inner edge by a very small amount. It should also be noted that the friction material only contacts the pressure plate on the outer edge by a very small amount. This explains why the friction material on the old driven plate has such a strange wear pattern.

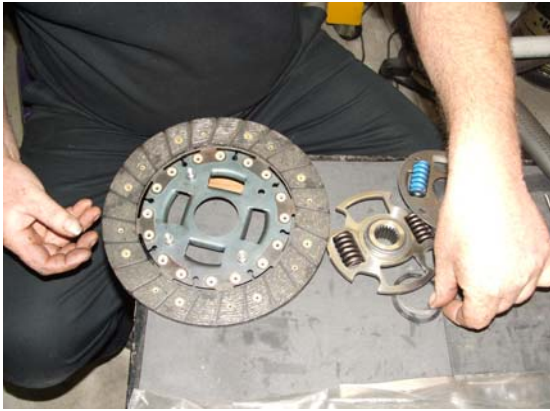
Dismantled clutch plate and spring pack

- b) The centre spline boss had the tapered counter-bore increased which provided an additional 0.080" (2.0mm) of off-set clearance
- c) The centre plate and spring assembly was removed by drilling out the four large securing rivets. Four new stepped rivets were manufactured to the same dimensions as the original items. These rivets were tested by riveting them to the old plate before attempting to install them in the new clutch plate
The riveting process was achieved by placing suitably mounted 0.500" diameter ball bearings either side of the rivet. The ends of the rivet were simultaneously peened over by using a 20 ton press that applied a force of 1500 psi. This produced a consistent mushroom head with a concave face.

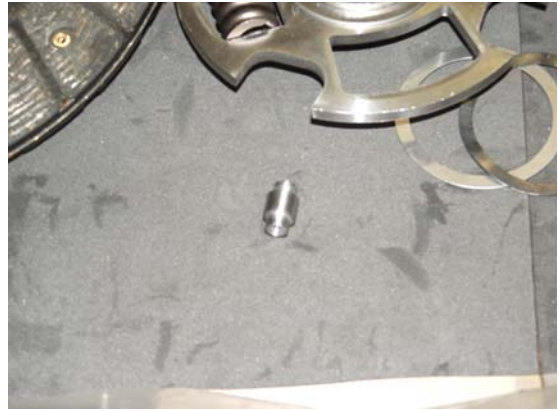
New stepped rivet for clutch plate

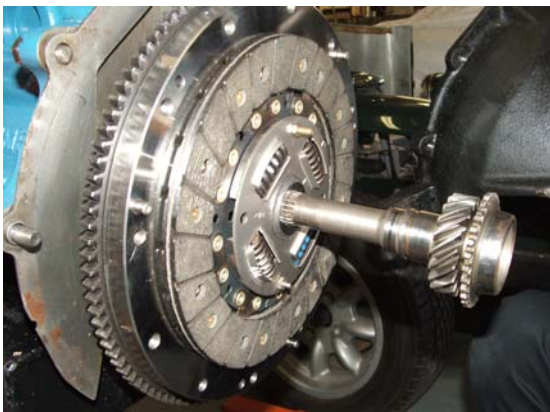
Dummy assembly of clutch plate

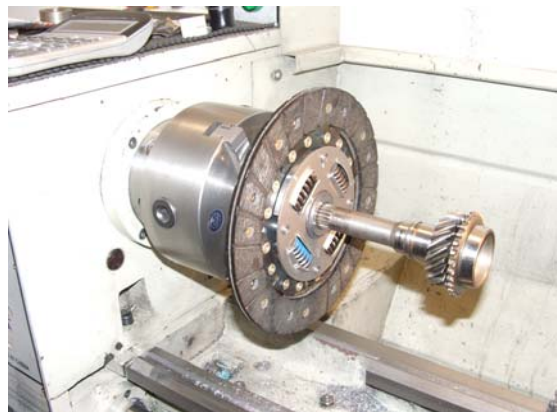
Clutch plate checked for run-out after riveting

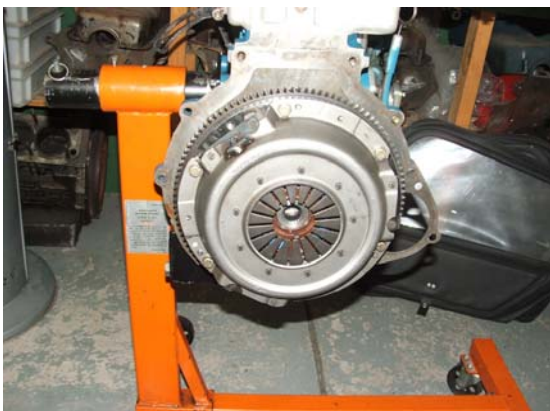
Non standard clutch assembly installed

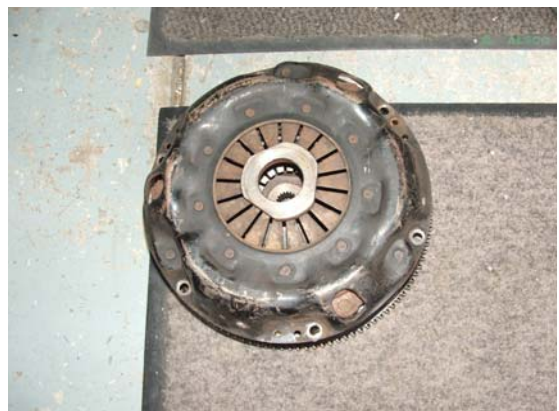
Standard twin cam clutch assembly
