Lotus Turbo Esprit excessive oil pressure problems

The following article is about a 1990 Turbo Esprit fitted with Delco fuel injection but not charge cooled. The engine had an oil pressure problem where it had approximately 110psi at idle speed. When the owner finally contacted us, the vehicle had been residing in another workshop at a European exotic car specialist for twelve weeks.

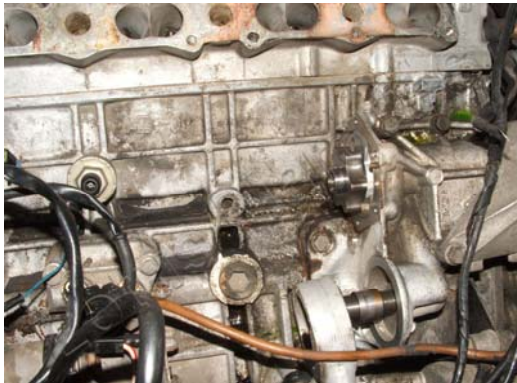
From details contained on the final invoice it appears some basic diagnostics were carried out that included checking all oil hoses for blockages, plus inspecting the oil pump. The excessive oil pressure problem was diagnosed as a blocked oil passage caused by a "spun bearing". However during the investigation process a number of problems were introduced into the vehicle. This included broken inlet manifold studs, broken stud removal tool bit, metal debris/swarf from attempting to drill out the broken studs. The metal debris from drilling exercise had entered the inlet ports, oil pump body and oil cooler sandwich plate.

Metal debris inside and outside the engine

- a. The removal of the broken studs and tool bit
- b. To heli-coil the cylinder head to accept new stainless steel studs
- c. The removal of swarf from the inlet ports and cylinders.

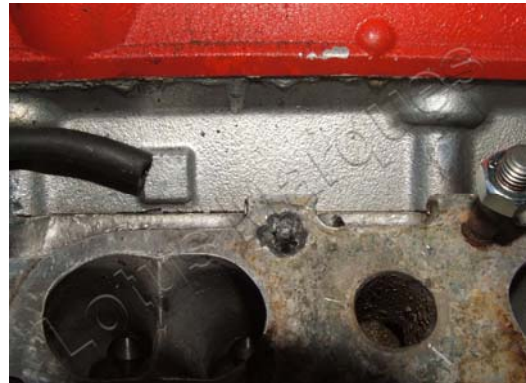
Broken stud removal tool bit

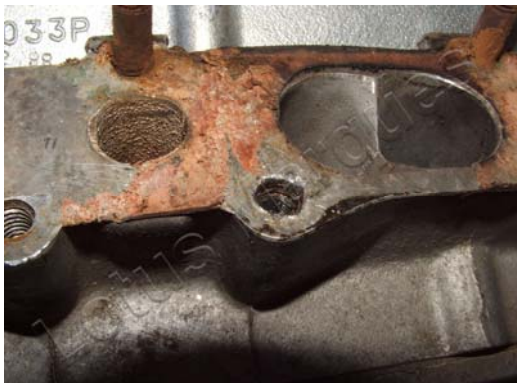
Leaking manifold gasket and corroded studs

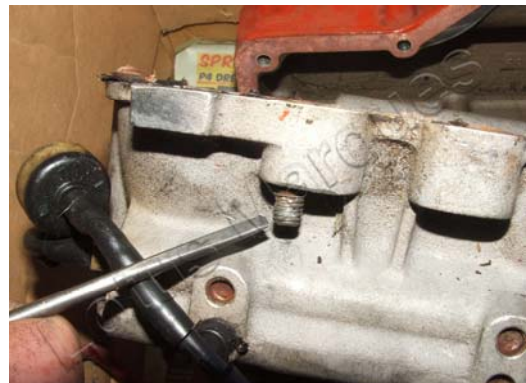
Broken stud retained in manifold

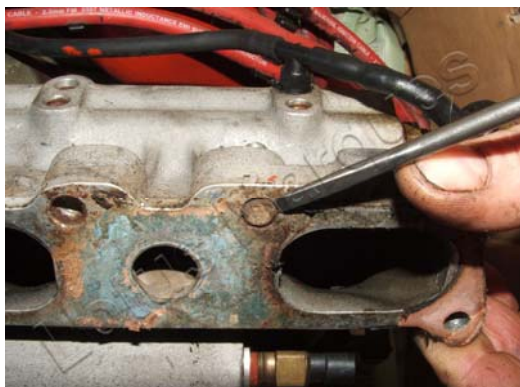
Flip side of broken inlet manifold stud

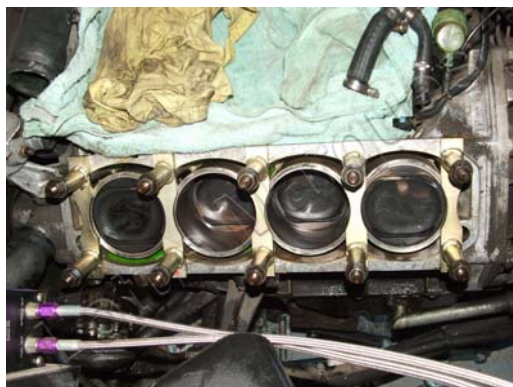
Cylinder head off and liner clamps on
Coolant left in engine block for a good reason!

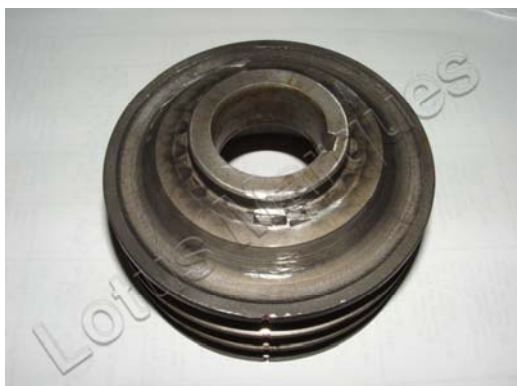
Damaged pulley from previous belt change

Whilst resolving the cylinder head and oil pump pressure issues, several other problems were observed. The forward edge of the camshaft timing belt was slightly “feathered”. This was caused by sharp edges of witness marks on the alloy crankshaft V pulley. The witness marks plus damaged grooves indicated the pulley had been difficult to remove and someone had hit it with a hammer. This was subsequently remedied by straightening the squashed V groove and machining off the sharp witness marks. In addition to this, the timing belt had been recently changed but the tensioner bearing and front camshaft oil seals had not been routinely replaced. When the tensioner bearing was checked, it was found to be dry which indicated there was no grease present to lubricate the internal ball race. The belt tensioner bearing, camshaft seals and timing belt were subsequently changed.

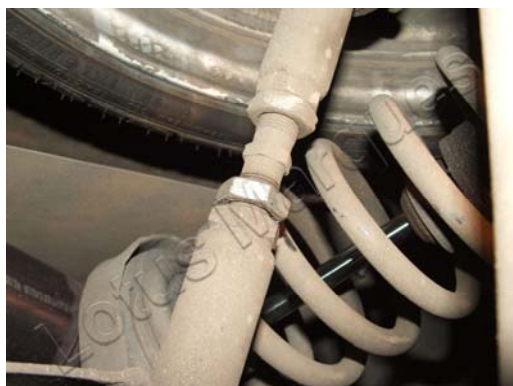
Rear adjustable top link lock nut unfastened

The rear top suspension link had been modified by making it adjustable but one of the lock nuts had come undone. This is not unusual as the link twists as the suspension moves from full bump to full droop. The force behind this twisting action is sufficient to unfasten the lock-nuts. This is one of the reasons why Lotus Marques manufacture a superior designed adjustable top link with spherical bearings that eliminates the twisting force applied to the lock-nuts.

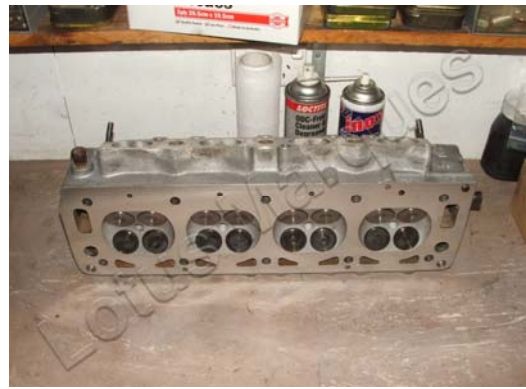
Overhauled cylinder head ready for installation

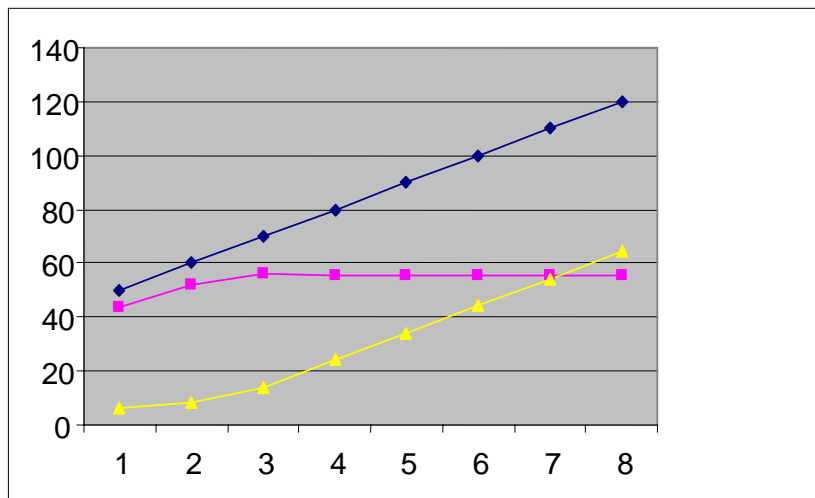
Results from testing the original pressure relief valve

The above graph shows the characteristics of the original oil pressure relief valve that was removed from the vehicle for testing. The relief valve maxed out at about 55psi (purple line) and refused to dump any more pressure as the primary input pressure was increased (uppermost dark blue line). This means that the resultant pressure that is applied to engine oil galleries (lower yellow line) continues to climb rapidly rather than regulating the pressure to desirable design limits. If this problem were left unchecked, then damage to the pump and/or driveshaft keyway would most likely occur.

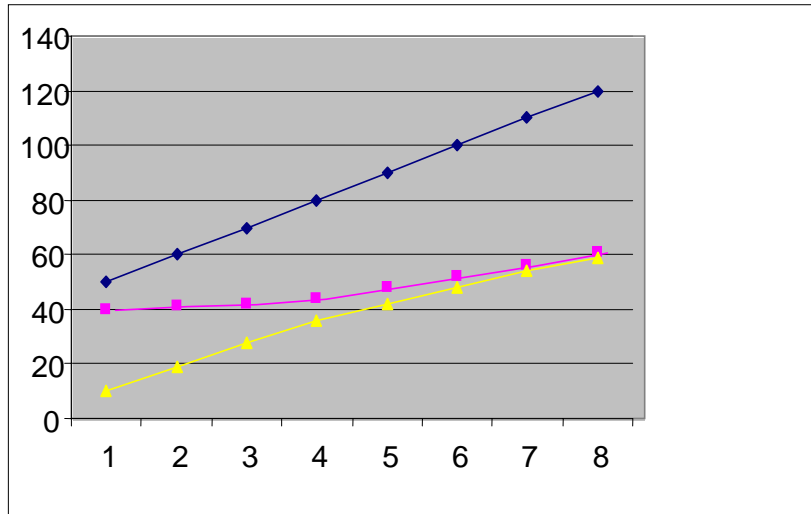
Results from testing the new pressure relief valve

The above graph shows the characteristics of the new oil pressure relief valve that was subject to testing prior to installation. The relief valve still continues to dump pressure (purple line) as the primary input pressure (uppermost dark blue line) was increased. This means that the resultant pressure that is applied to engine oil galleries (lower yellow line) is regulated and maintained within the design parameters.
