Lotus Esprit Turbo alternator problems

After many years of use and temperature cycling, there is a pattern emerging where the voltage regulators are failing in Valeo alternators (part number 2518035, 90 amp output) as fitted to the Lotus Esprit and Excel. However, there is a warning sign where the epoxy-resin runs out of the aluminium casing and drips on to the components below (usually the air-conditioning compressor). Once the resin melts and drips out of the casing, it leaves the solid-state circuit exposed to dirt and condensation. In a short space of time the unit fails completely and the alternator no longer charges the battery, leaving the owner stranded.

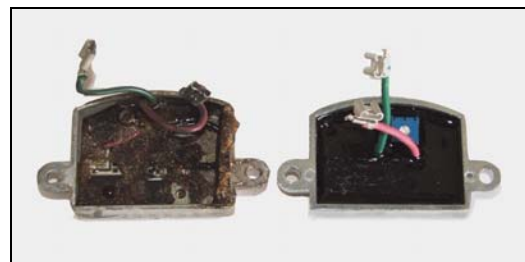
Removing the faulty regulator

Before attempting to carry out any electrical repair work, the battery must be disconnected as a safety precaution. A car battery stores large amounts of energy that can cause significant damage (even fire) if the cables or battery terminals are shorted together.

1. Remove the two regulator mounting screws (save the screws) at the rear of the alternator
2. Partially remove the regulator and disconnect leads at the alternator terminals
3. Finally remove and discard the faulty regulator

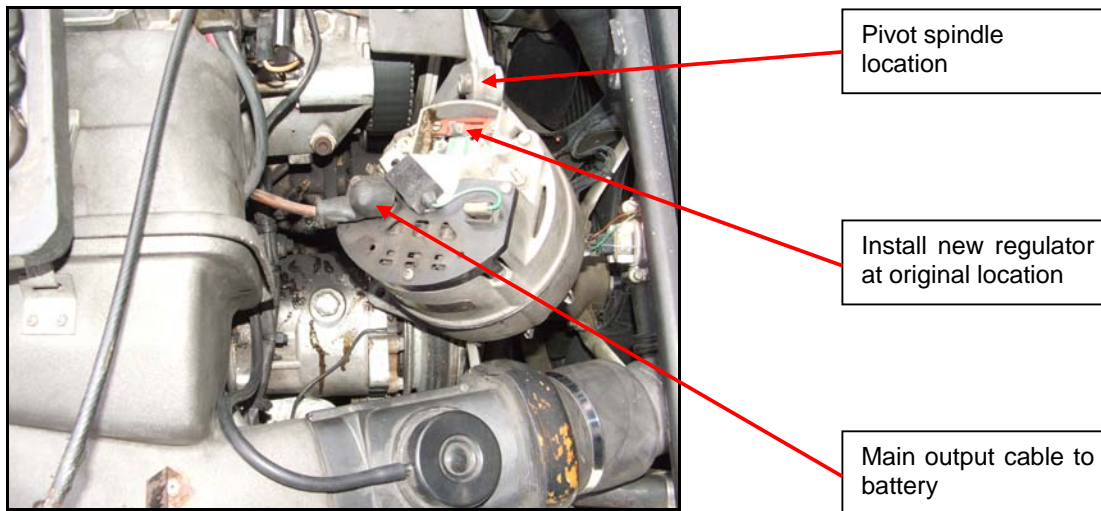
Whilst replacing the regulator it is recommended that a load test be carried out. This ensures the alternator is charging correctly when delivering large currents and there is no volt-drop (high resistance joint) present. From experience, we have found a re-occurring problem where a high resistance joint has been discovered between the alternator body and auxiliary housing. This is caused by condensation/corrosion building up around the alternator 8.0mm diameter pivot spindle. This problem can be checked for by placing the probe tips of a high quality DVM between the alternator body and auxiliary housing. The DVM should be set on a sensitive DC voltage range eg. 2.5 volts. Typical voltage drop detected across these components has been between 0.65 volts to 1.75 volts. This is easily solved by removing the alternator, cleaning the spindle, coating it with anti-seize compound and then re-installing it. Coating the spindle in anti-seize compound has a two-fold effect where it prevents moisture ingress and also provides a conductive path. It is also recommended that a braided earth lead be installed between the alternator metal casing and auxiliary housing to eliminate future problems.

This problem can be very subtle as it is not immediately obvious. It is also not possible to see the corroded spindle as it is concealed by the alternator and auxiliary housing alloy castings. It is not until both the alternator and spindle are fully removed, that the corrosion can be examined. Symptoms of this, is when the car will not start the next day, where the battery is not charged properly as the result of night driving. If the battery is re-charged, the car will then operate perfectly during day time driving until the next night time outing.
