# Elan Factory Customer Projects

March 2006

## Vehicle details

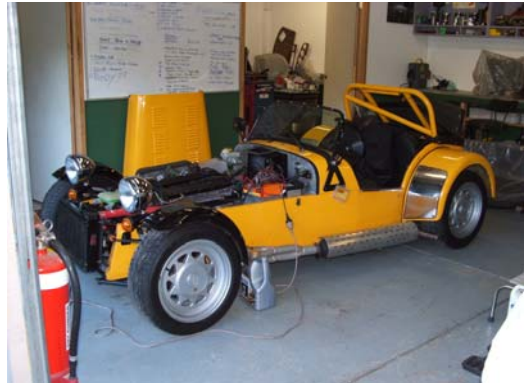
Bonnet off and battery charger installed

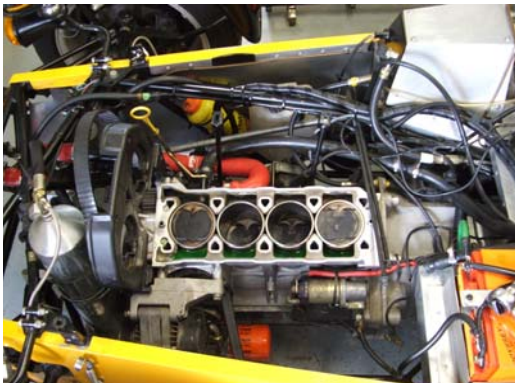
Cylinder head off the K16 series engine

This well prepared vehicle that has recently been purchased from New South Wales and has been brought to The Elan Factory for a pre-purchase inspection and a Road Worthy Certificate. Unfortunately before the owner could register the vehicle, the coolant pressure cap failed and this resulted in a blown head gasket. This problem was quickly resolved by removing the cylinder head for machining and then carefully reassembling the engine with a new stainless steel head gasket.

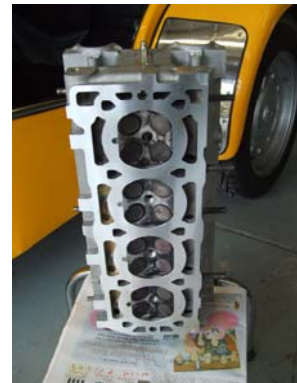
Cylinder head after machining

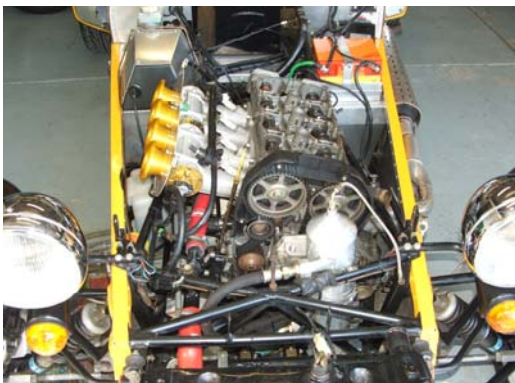
Engine with cam cover removed

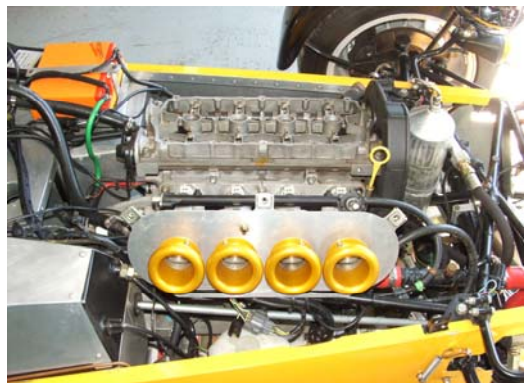
Induction system

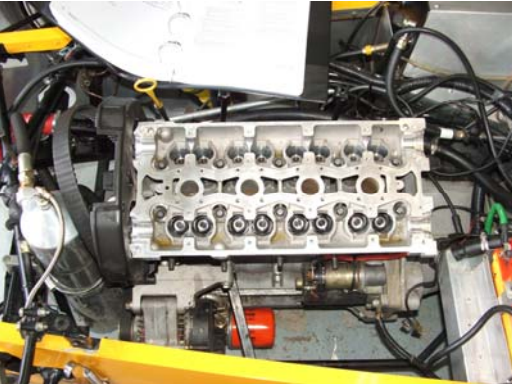
Cylinder head bolt installation

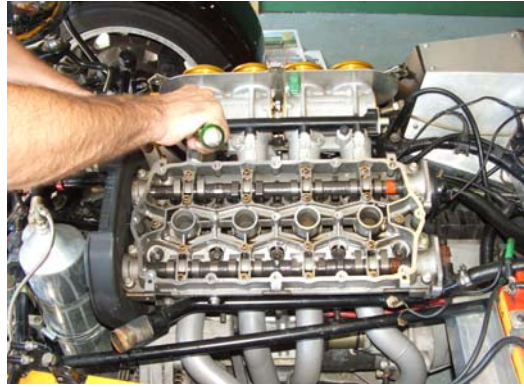
Cam housing and exhaust system installed

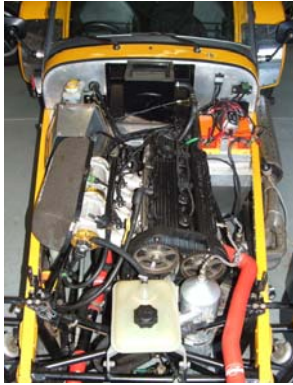
Front view of engine bay
