# Elan Factory Customer Projects

March 2006

## Vehicle details

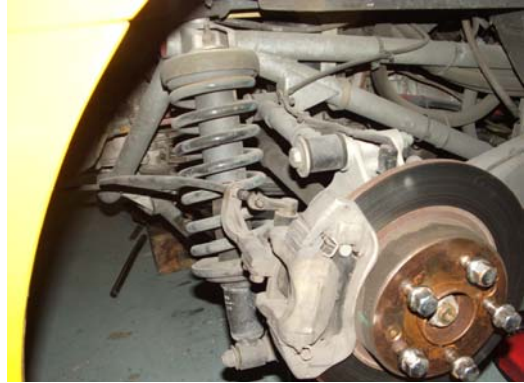
Rear calliper assembled and adjusted incorrectly. Note hand brake lever tight against outer armoured cable.

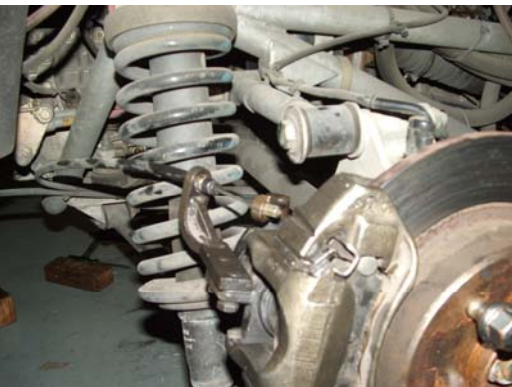
Drivers side rear brake caliper showing the hand brake lever in the correct position after remedial action

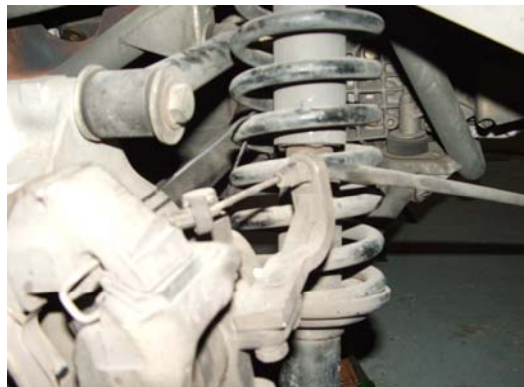
Passenger side rear brake caliper showing the hand brake lever in the correct position

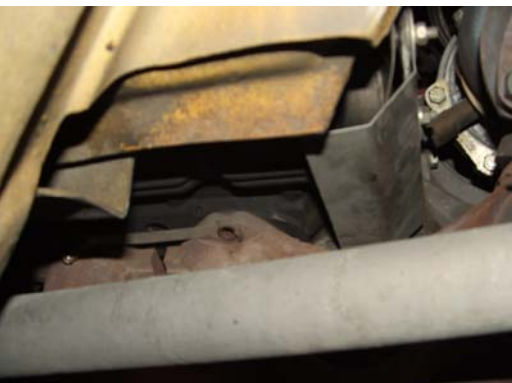
Number 4 cylinder exhaust manifold fastener missing. Note lock tab still in position which was re-used after installing a new fastener

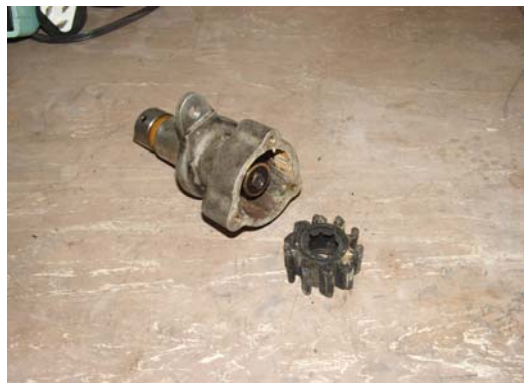
A dismantled charge cooler pump reveals the rubber impellor had failed. This results in a reduction of engine power
