The Elan Factory – Product Data Sheet

Lotus Esprit Turbo radiator fan cowling (Lotus part number E082K4102K)

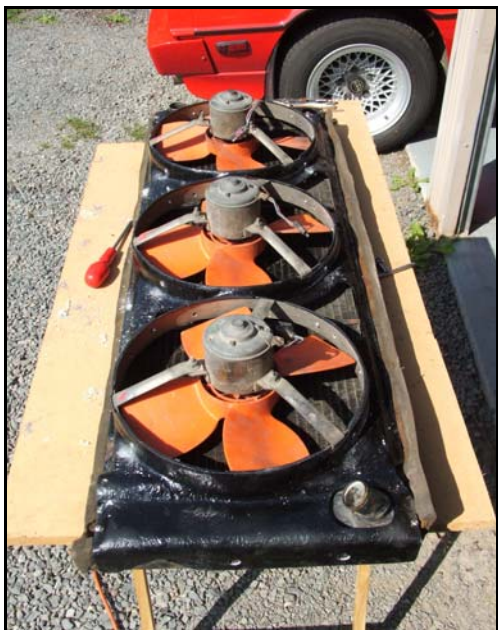
The adjacent photograph portrays the original fans and mountings that have been transplanted from an old cracked shroud to a new fibreglass fan shroud.

The next step is to dismantle the damaged shroud by removing the assembly from the radiator and then releasing the fans by drilling out the pop-rivets. Once the fans, supports stays and hoops are free, they can then be fastened into the new fibreglass shroud. Care should be taken not to damage the radiator core during this process. Once the fans are fastened in their respective locations, the interconnecting wiring loom must be fastened to the shroud by means of tie-wraps (zippy-clips). It is recommended that all three fans be tested off the vehicle before being installed into the new shroud.
