Elan Factory Customer Projects

October 2007

Vehicle details

The alternator below has come from a late model V8 Esprit. The owner has experienced a low voltage output from the alternator that resulted in the battery not being fully charged. The alternator problem was subsequently traced to a faulty voltage regulator that was changed by the following procedure below.

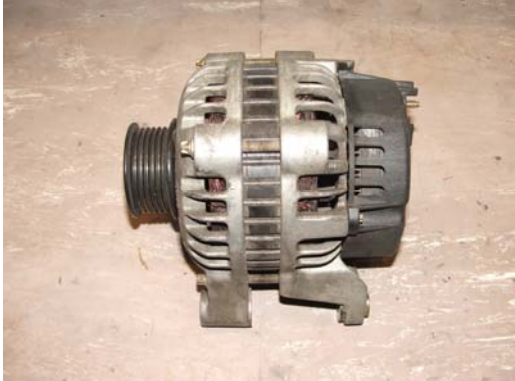
Standard alternator for V8 Esprit

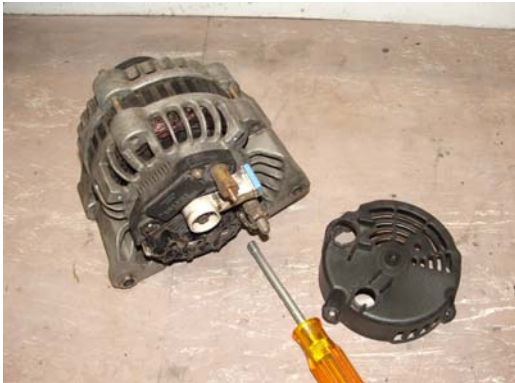
Alternator cover removed
