The Elan Factory – Product Data Sheet

Esprit Turbo ABS accumulator (Lotus part number A082J6138S)

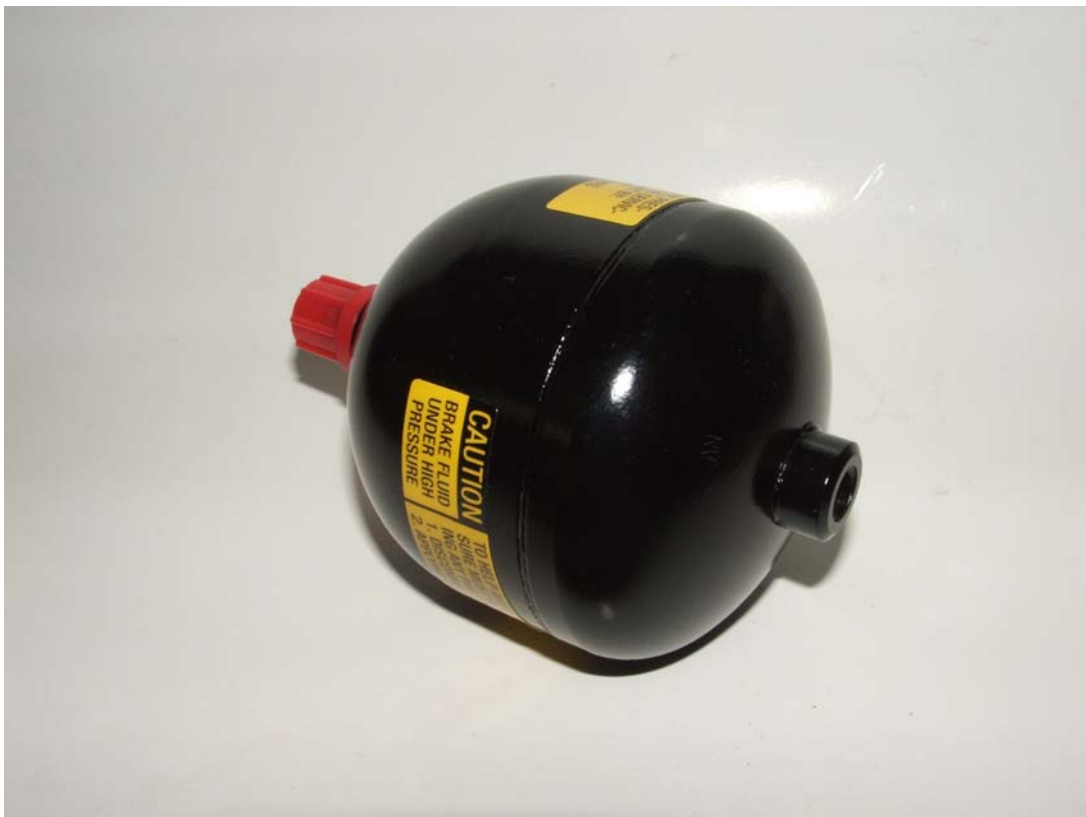
Under normal operating conditions the accumulator stores brake fluid supplied by the pump which is maintained at a high pressure of between 2200psi and 2700psi. If the accumulator is diagnosed as being faulty, the replacement procedure should be followed as per Section JF.18, page 63 in the Lotus Service Notes (Braking System including Delco Moraine ABS 111A)

1. **Depressurise the accumulator** by turning off the ignition and FIRMLY applying the brake pedal 40 times. A noticeable change in the pedal feel (to a hard pedal) will occur when the accumulator is completely discharged.
2. Unscrew the accumulator from the endplate using a 17mm socket. (this maybe be a different type of fastener for after-market accumulators)
3. Fit a new 'O' ring on the accumulator spigot and lubricate with DOT 4 fluid. Screw the accumulator into the endplate and tighten to 31 – 35 Nm (23 – 25 lb.ft)
4. Bleed the brake system as in JF.8
